**Flood Control Project Maintenance
Levee Inspections**
LMA District Cover Sheet
Spring 2017 Levee Inspection Results

Sacramento Maintenance Yard Putah Creek

Spring 2017 Levee Inspection Results

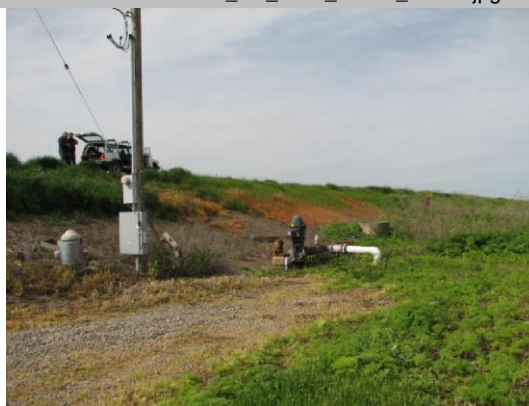
Photo 2 of 3 : UCIP_SP_2017_33408_60495.jpg

LS pump and appurtances

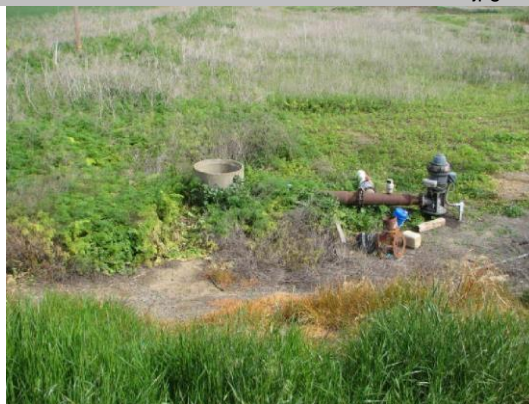
Photo 3 of 3 : UCIP_SP_2017_33408_60494.jpg

LS pump and appurtances

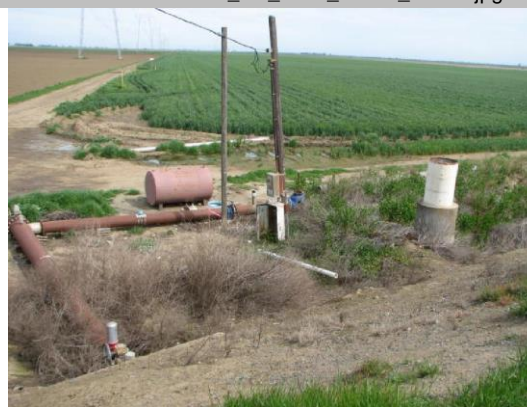
Photo 2 of 3 : UCIP_SP_2017_48122_60483.jpg

FS_ID:48122
DS_ID:489
EP_NO: 10262
Repair Type: Non-Urgent
Crossing Status: Found
UCIP Comments: Pump is disconnected from pipe and could cause backflow at highwater event. Can't see size of pipe sleeved through 24-inch pipe.
FIELD_STRUCT_DESC: 18-inch steel irrigation pipe (field verified not 16-inch) sleeved through existing 24-inch drainage steel pipe through levee, 12.5 feet below the crown. Annular space sealed at both the waterside (WS) and landside (LS) ends. Concrete headwalls are located on both the WS and LS ends. PVC sleeved December of 2007 (unknown source). (16-inch pipe sleeved through 24-inch pipe authorized under Automatic Board Order (ABO) issued as Permit No. 10262, 1974 - Wells Fargo Bank, Trustee for S.H. Cowell Foundation)
[Additional Reference(s): DWR Levee Log, March 2007. USACE Sacramento O&M Manual 119, December 1952]
FS Date: 4/10/2014 2:48:00 PM

pipe and pump/apertances on LS

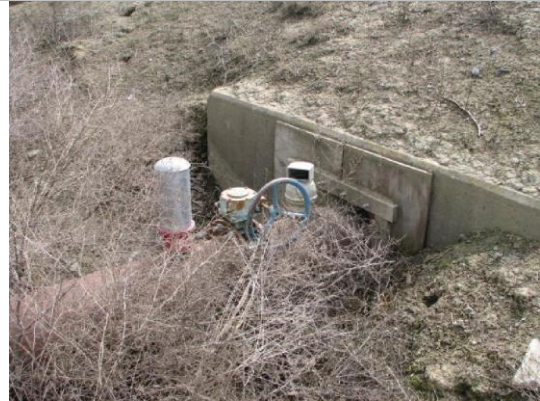
Photo 3 of 3 : UCIP_SP_2017_48122_60482.jpg

Comment Code					
Inspector Comment					
FS_ID:48122 DS_ID:489 EP_NO: 10262 Repair Type: Non-Urgent Crossing Status: Found UCIP Comments: Pump is disconnected from pipe and could cause backflow at highwater event. Can't see size of pipe sleeved through 24-inch pipe. FIELD_STRUCT_DESC: 18-inch steel irrigation pipe (field verified not 16-inch) sleeved through existing 24-inch drainage steel pipe through levee, 12.5 feet below the crown. Annular space sealed at both the waterside (WS) and landside (LS) ends. Concrete headwalls are located on both the WS and LS ends. PVC sleeved December of 2007 (unknown source). (16-inch pipe sleeved through 24-inch pipe authorized under Automatic Board Order (ABO) issued as Permit No. 10262, 1974 - Wells Fargo Bank, Trustee for S.H. Cowell Foundation) [Additional Reference(s): DWR Levee Log, March 2007. USACE Sacramento O&M Manual 119, December 1952] FS Date: 4/10/2014 2:48:00 PM

Butterfly valve at LS toe

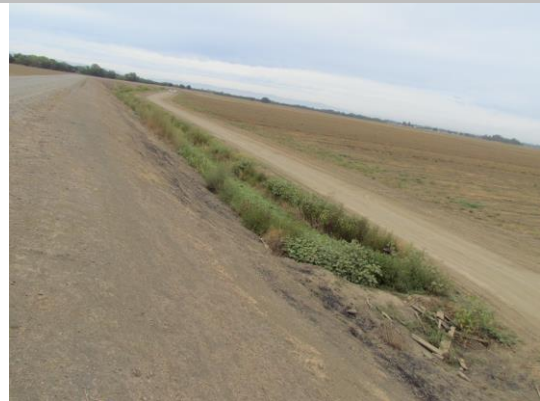
Photo 1 of 1 : SP_2017_ST0007_282_10_20170404_00004.jpg

LM Start	1.48	Rating **	M	Issue No.	10
LM End	2.67	Issue Type +	En	Location *	LS
Category	Earthen Levee			GPS Latitude/Longitude	
				Start	End
Item	Encroachments			38.515322 °	38.517376 °
				-121.654387 °	-121.676054 °
DWR ID	DWR_ST0007_01_s_2012_10				
Comment Code					
DT : Ditch					
Inspector Comment					
This agriculture ditch is owned by Dos Rios Farms. Ending at levee mile 2.72 landside.

Agriculture ditch within 10-foot of levee toe.

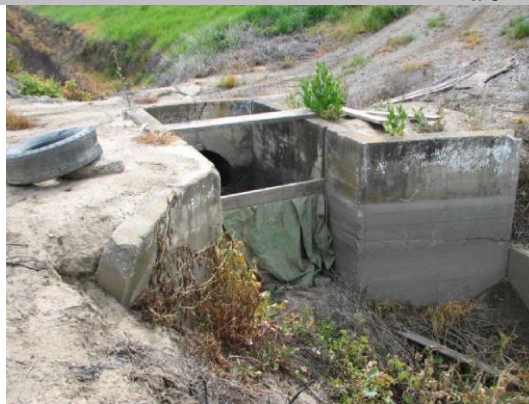
Photo 2 of 3 : UCIP_SP_2017_43033_60467.jpg

LS distribution box

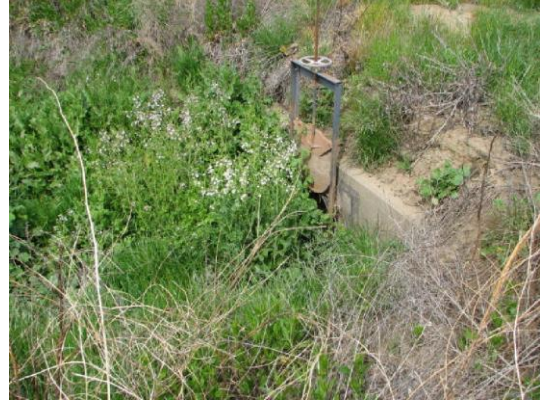
Photo 3 of 3 : UCIP_SP_2017_43033_60466.jpg

Comment Code					
Inspector Comment					
FS_ID:43033					
DS_ID:491					
EP_NO: 10262					
Repair Type: Non-Urgent					
Crossing Status: Found					
UCIP Comments: Pipe has significant rust and exfoliation of metal showing at ends. Reccomend video inspection.					
FIELD_STRUCT_DESC: 24-inch irrigation pipe of unknown material through levee, 15.5 feet below crown. Slide gate is located on the waterside (WS) end. Concrete headwall is located on the landside (LS) end. (24-inch pipe authorized under Automatic Board Order (ABO) issued as Permit No. 10262, 1974 - Wells Fargo Bank, Trustee for S.H. Cowell Foundation) [Additional Reference(s): DWR Levee Log, 1981 and 2005. USACE Sacramento O&M Manual Unit 119, December 1952, (Station XX+XX)]					
FS Date: 4/10/2014 2:45:00 PM

WS slide gate with vegetation

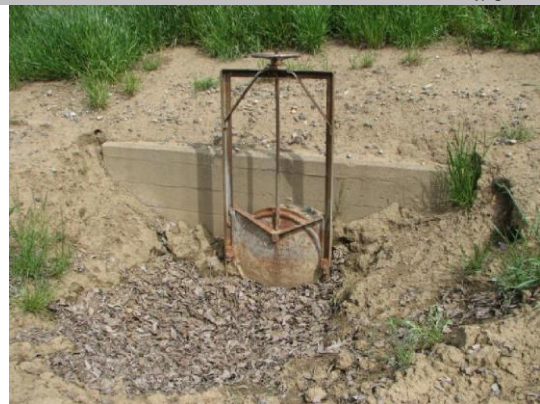
Photo 1 of 2 : UCIP_SP_2017_33394_60458.jpg

WS Slide gate

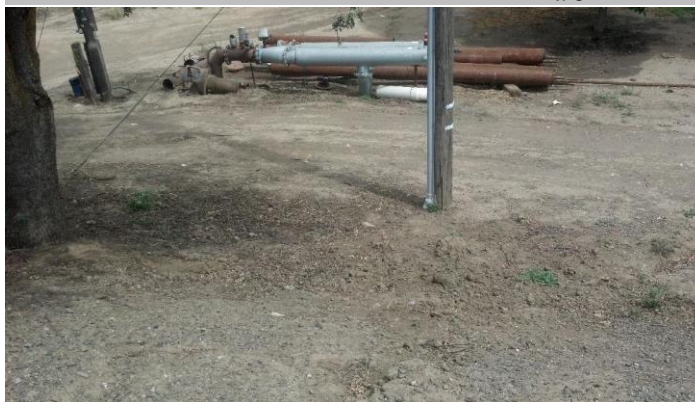
Photo 1 of 3 : UCIP_SP_2017_48013_60451.jpg

LM Start	3.22	Rating **	M	Issue No.	43
LM End	3.22	Issue Type +	En	Location *	LS
Category	Supplemental			GPS Latitude/Longitude	
				Start	End
Item	DWR UCIP Field Study			38.519731 °	38.519731 °
				-121.685681 °	-121.685681 °
DWR ID					
Comment Code					
Inspector Comment					
FS_ID:48013 DS_ID:16849 EP_NO: N/A Repair Type: Non-Urgent Crossing Status: Found UCIP Comments: Old pipe and concrete hauled to county dump. Evidence of the 14-inch pipe is no longer present at site. See new picture. FIELD_STRUCT_DESC: 10-inch steel irrigation pipe through the levee, 12 feet below the crown. Pipe terminates at standpipe located on the waterside (WS) approximately 500 feet south of levee. Mobile pumping plant is located in the floodway at edge of stream 740 feet south of levee. FS Date: 4/10/2014 2:42:00 PM

Filter Plant on LS toe

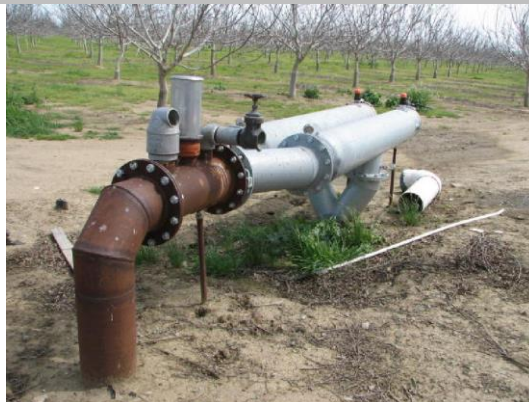
Photo 3 of 3 : UCIP_SP_2017_48013_60450.jpg

10-inch pipe at LS toe.

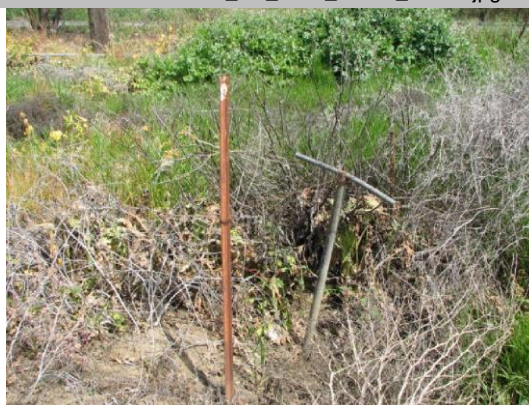
Photo 1 of 3 : UCIP_SP_2017_33381_60439.jpg

WS toe at T handle. No access to pipe.

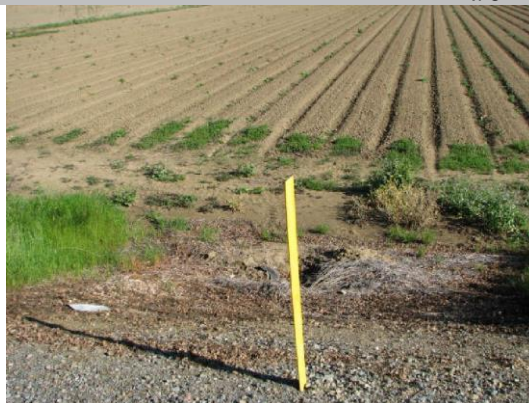
Photo 2 of 3 : UCIP_SP_2017_33374_60423.jpg

LS shoulder looking down on headwall

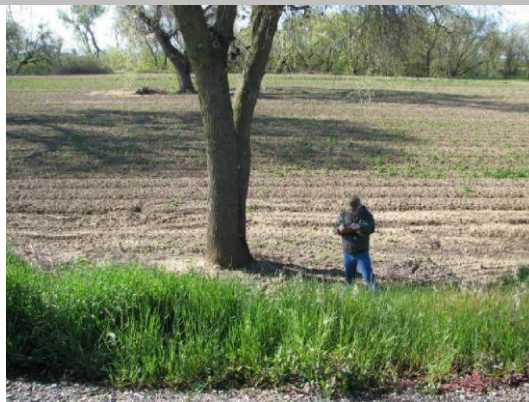
Photo 3 of 3 : UCIP_SP_2017_33374_60425.jpg

WS toe looking down from shoulder

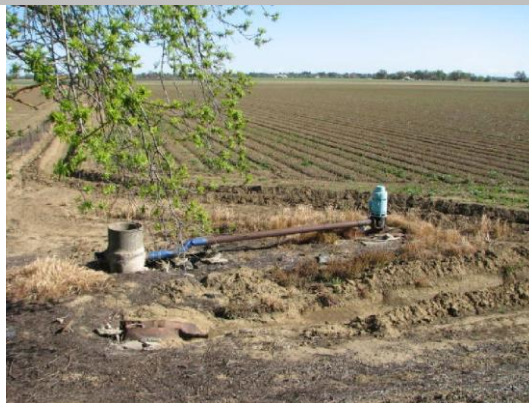
Photo 1 of 2 : UCIP_SP_2017_33370_60415.jpg

LS pump and stand pipe

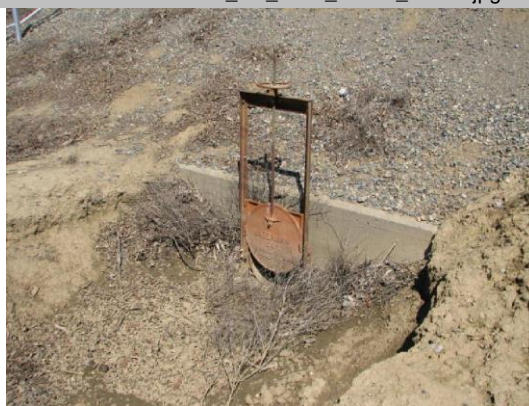
Photo 2 of 2 : UCIP_SP_2017_33368_60409.jpg

WS slide gate

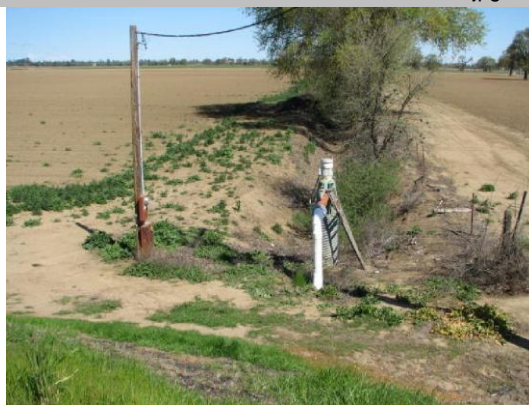
Photo 1 of 3 : UCIP_SP_2017_33367_60406.jpg

LS pump and pipe

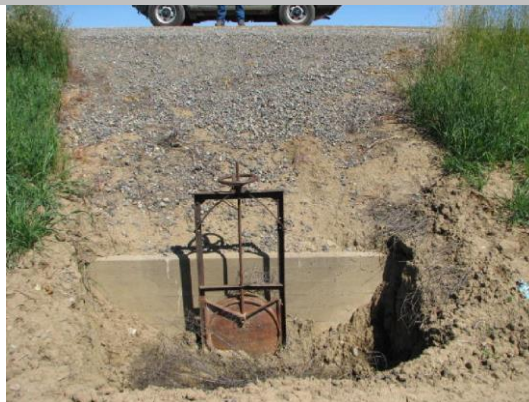
Photo 2 of 2 : UCIP_SP_2017_33364_60400.jpg

FS_ID:33364
DS_ID:503
EP_NO: 10252
Repair Type: No Action Needed
Crossing Status: Found
UCIP Comments: owner of pipe needs to clean out obstruction in pipe.
FIELD_STRUCT_DESC: 24-inch drain pipe through the levee 12.0 feet below the crown. Slide gate on waterward end. Concrete head wall on landward end. (ABO No. 10252 - Hamel)
FS Date: 4/10/2014 2:34:15 PM

WS headwall and slidegate

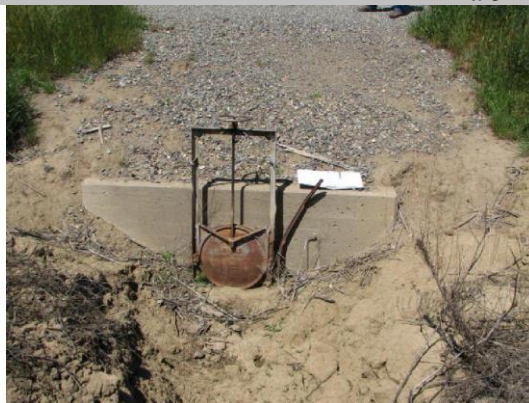
Photo 1 of 2 : UCIP_SP_2017_33349_60372.jpg

WS Slide Gate

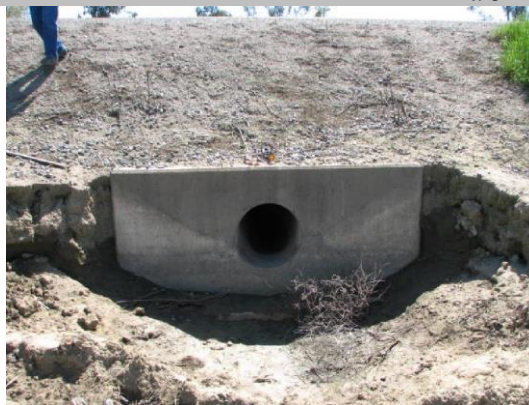
Photo 2 of 2 : UCIP_SP_2017_33349_60371.jpg

LS Headwall

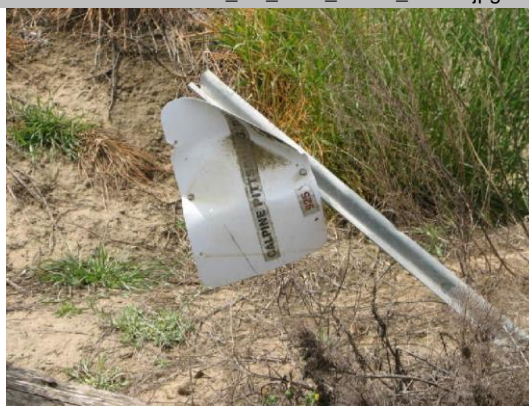
Photo 1 of 2 : UCIP_SP_2017_33347_60366.jpg

FS_ID:33347
DS_ID:506
EP_NO: 10820
Repair Type: Non-Urgent
Crossing Status: Indicator Found
UCIP Comments: Sign on LS bent over and broken. New signs need to be installed locating pipe that indicate a gas line crossing. The broken or missing signs do not indicate gasoline, only owner info. Owner is Calpine NRG Scott Vickers 707-249-9211. Supervisor will call phone number and ask for new signs to be installed.
FIELD_STRUCT_DESC: 4-inch gas pipeline through the levee 2 feet below the crown. (App. No. 10820 - Dow Chemical)
FS Date: 4/10/2014 2:28:50 PM

LS sign post with damaged sign.

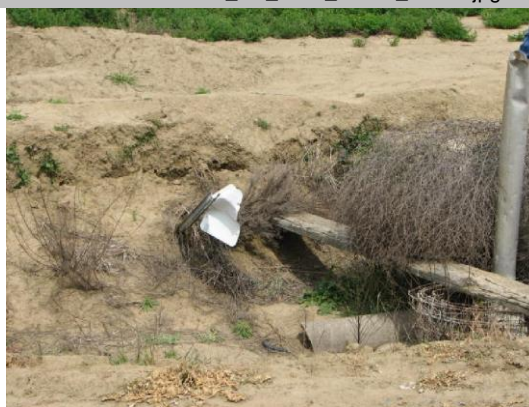
Photo 2 of 2 : UCIP_SP_2017_33347_60365.jpg

LS: sign post bent over in v ditch at toe.

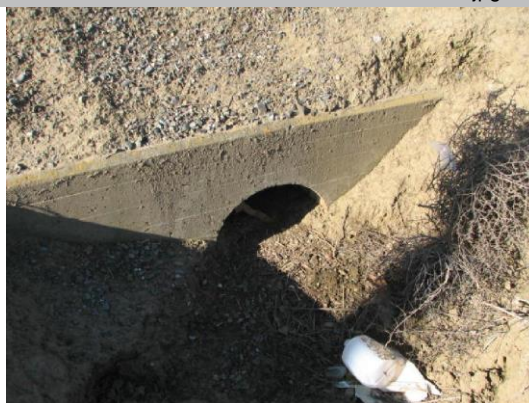
Photo 2 of 2 : UCIP_SP_2017_41353_60344.jpg

LS headwall showing pipe partially blocked with soil.

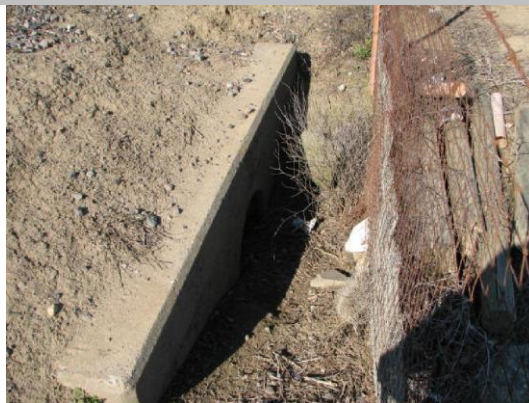
Photo 2 of 2 : UCIP_SP_2017_33333_60341.jpg

LS headwall showing fence and soil buildup.

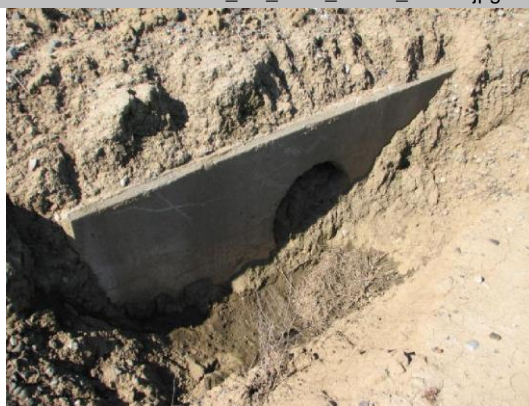
Photo 2 of 3 : UCIP_SP_2017_33328_60327.jpg

LS headwall showing pipe plugged with soil

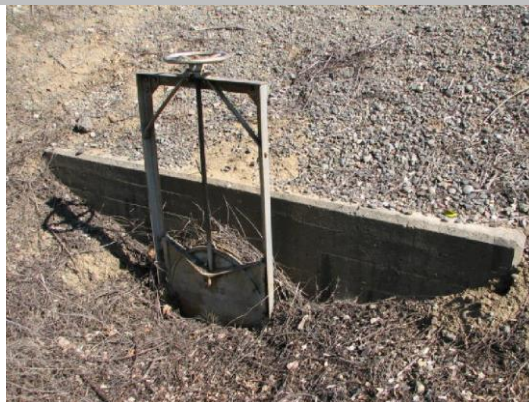
Photo 3 of 3 : UCIP_SP_2017_33328_60328.jpg

WS slide gate showing some blockage with soil.

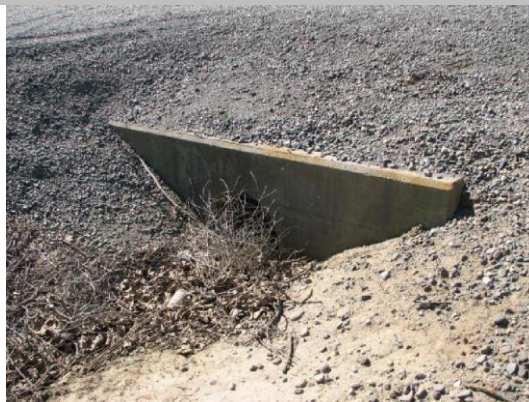
Photo 2 of 2 : UCIP_SP_2017_33327_60325.jpg

LS headwall showing partial blockage

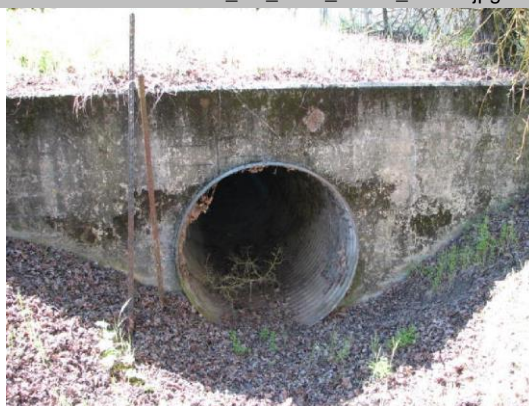
Photo 2 of 3 : UCIP_SP_2017_41129_60299.jpg

LS headwall and pipe before steel plate was installed over pipe to abandon it.

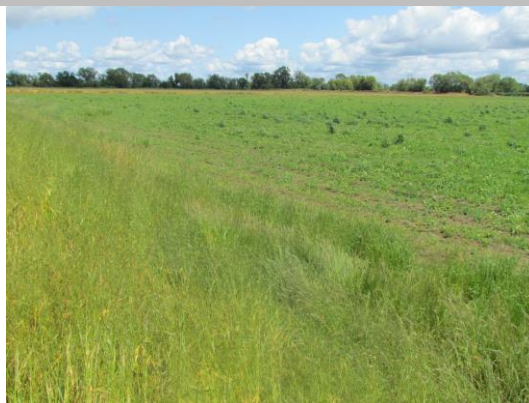
Photo 1 of 1 : SP_2017_ST0007_283_20_20170511_00067.jpg

Looking at the levee toe there is an irrigation ditch, tall weeds block the view.

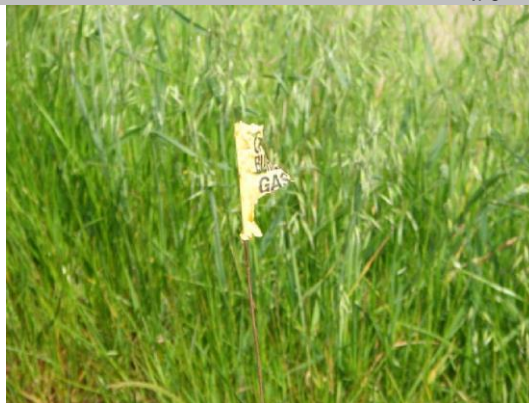
Photo 2 of 3 : UCIP_SP_2017_33400_60472.jpg

small flag on WS shoulder

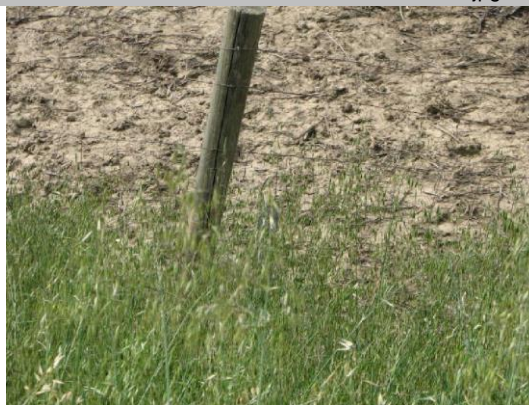
Photo 3 of 3 : UCIP_SP_2017_33400_60473.jpg

steel sign marker at LS toe with no sign

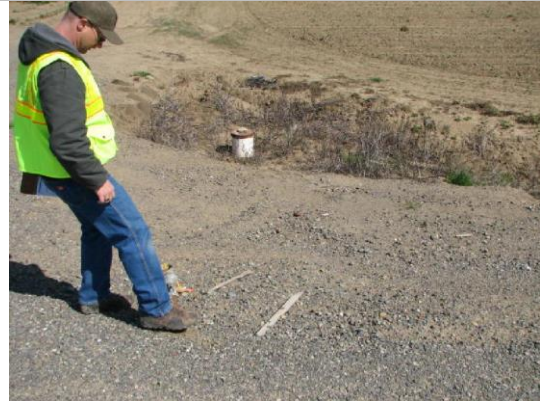
Photo 1 of 1 : UCIP_SP_2017_33392_60454.jpg

WS shoulder showing air vent with no sign and 18-inch standpipe at WS toe.

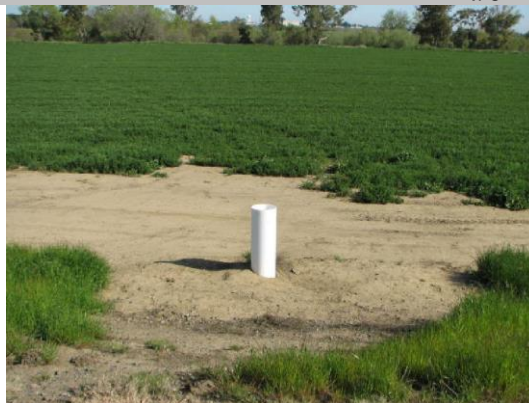
Photo 1 of 1 : UCIP_SP_2017_41074_60419.jpg

15-inch standpipe at location where may run through 24-inch SD.

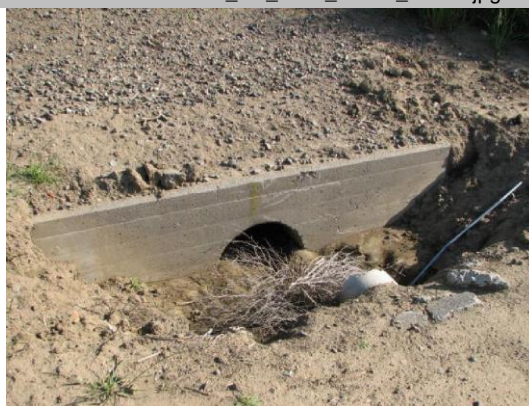
Photo 2 of 3 : UCIP_SP_2017_33369_60413.jpg

L/S Clogged

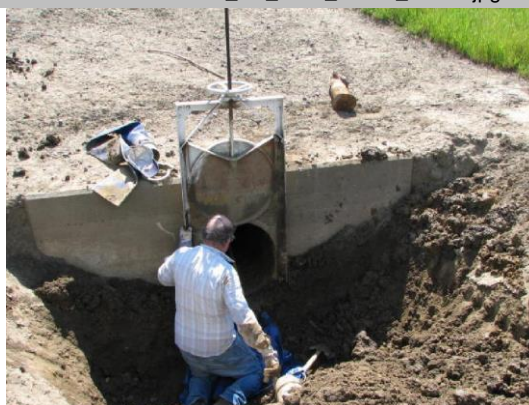
Photo 1 of 2 : UCIP_SP_2017_33363_60399.jpg

WS slide gate and headwall. 6-inch irrigation pipe just inside 24-inch pipe.

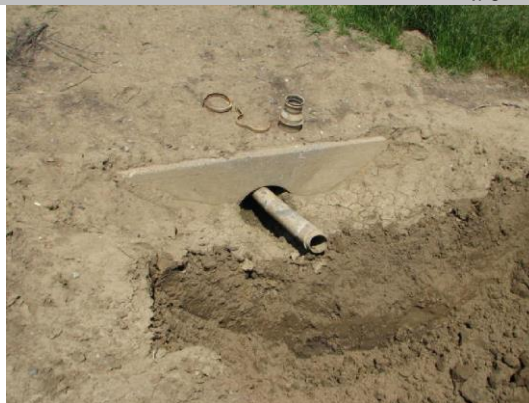
Photo 2 of 2 : UCIP_SP_2017_33363_60398.jpg

LS headwall showing sedimentation and 6-inch pipe sleeved through 24-inch pipe.

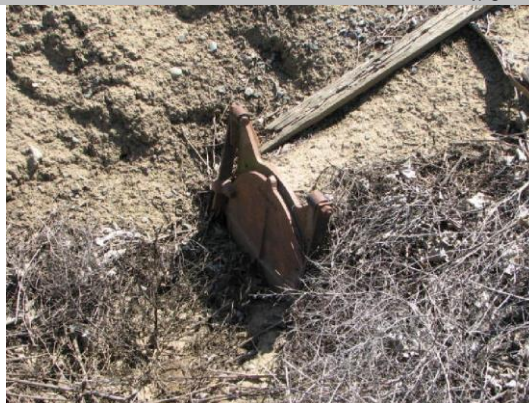
Photo 1 of 2 : UCIP_SP_2017_42953_60397.jpg

WS Flapgate blocked by sedimentation

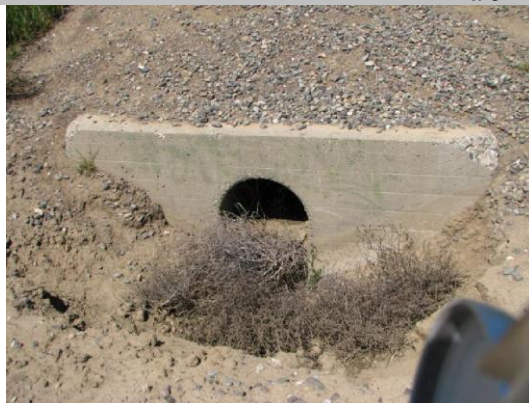
Photo 1 of 2 : UCIP_SP_2017_33353_60380.jpg

LS headwall and pipe showing sediment buildup.

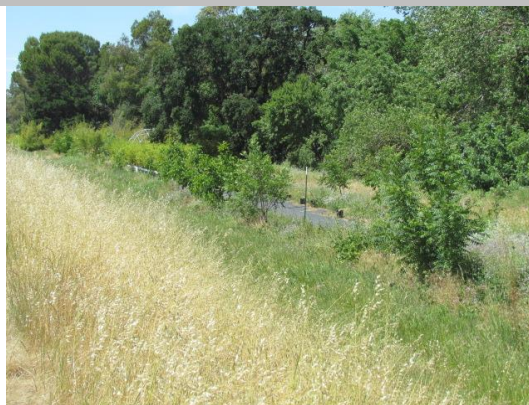
Photo 2 of 2 : SP_2017_ST0007_283_41_20170511_00064.jpg

Levee mile 6.63-6.74 waterward berm landowner has several hundred bamboo planting and other crops.

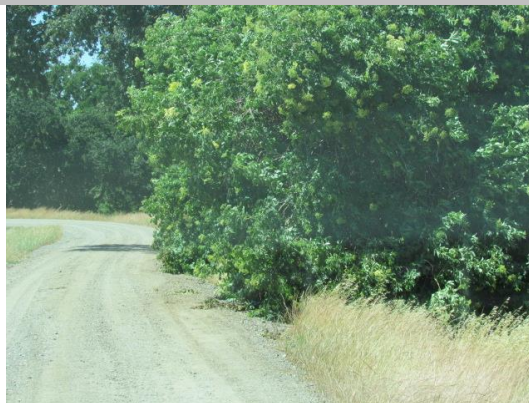
Photo 1 of 1 : SP_2017_ST0007_283_47_20170511_00061.jpg

Elderberry bushes blocking view of waterside shoulder at this location.
